The Role of Building Sciences in Predictive Maintenance Programs

Phillip C. McMullan

Thermo-Scan Inspections, Carmel, Indiana

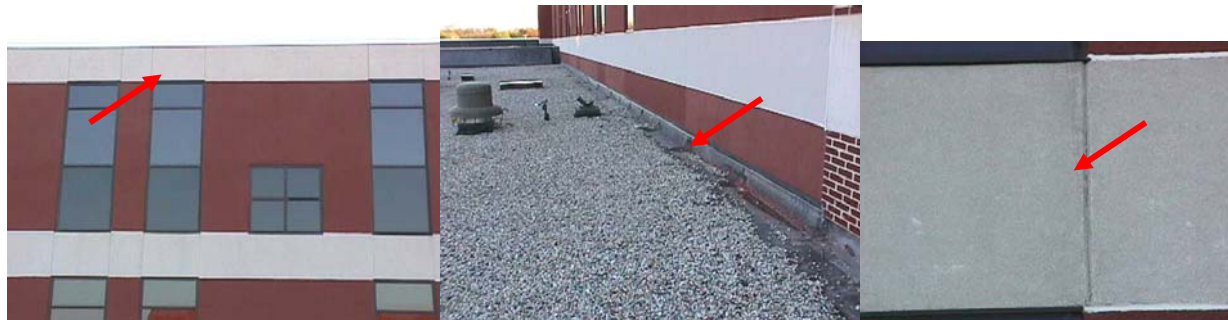
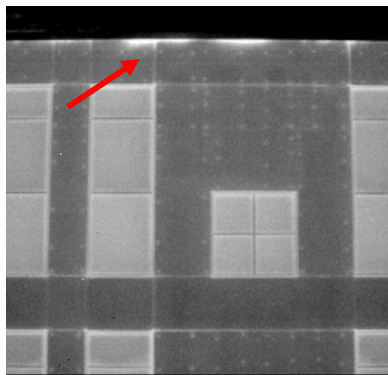
FIGURE 1

The south wall of this newly constructed three-story building was the focus of the inspection. At the junction of the new construction and the single story existing construction an active leak had developed. After pressurizing the facility and thermally imaging the exterior elevations, three leakage sites were documented. Beginning with **FIGURE 1**, the parapet cap flashing was found to be leaking. In other words, it was exhausting warm interior air from under the metal cap detail. While this finding might be considered typical of building of this construction, at this south elevation was the only elevation that presented this thermal pattern. Additionally, the active water leaks

only occurred when there was a driving rain storm (except when snow was involved) from the southeast. Pressure differential at this location measured just less than 18 Pa with an interior pressure of 18.2 Pa on the third floor. These two facts, keeping in mind that no other elevation, north, east or west presented this thermal pattern offer strong evidence that this location could leak water under certain environmental conditions. Additionally, this air leakage is an energy and comfort concern for the building.

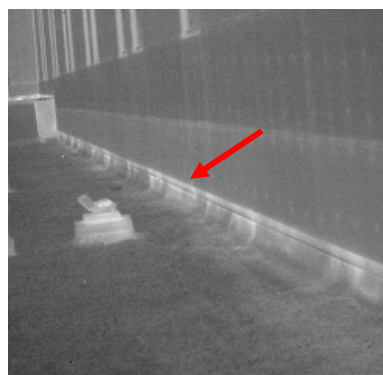
FIGURE 2

At first floor roof level, the location where the new three story building was connected to the existing one story building, a pattern of air leakage was also present, **FIGURE 2**. At this location the interior pressure measured 11.5 Pa and the leakage site, which is at the base flashing detail, measured positive 3.8 Pa. After discussions with facility personnel, it was discovered that when snow would “drift” against this wall a water leak would develop. Further examination of the base flashing detail revealed a significant crack at the bottom of the EIFS. As with the first leak site, given certain environmental conditions this detail was a location for water leakage into the building.

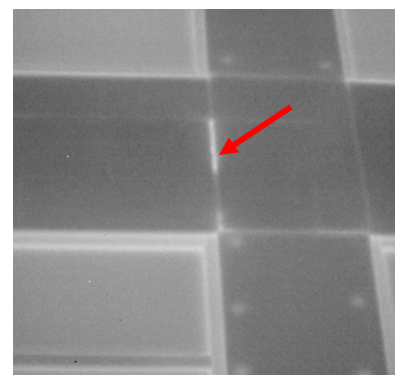
FIGURE 3

Finally, a third location of air leakage on this wall was documented. **FIGURE 3** shows the seam of two insulation boards and the crack in the finish system leading to the leak. This thermal pattern was found in numerous locations throughout the south elevation. While some were large, most were very small. Many were at locations where the caulking had not properly adhered to the finish. Each crack presents a very definite thermal signature of air leakage. Again, if air can leak through the wall under induced positive pressure, water can leak into the building with certain environmental conditions.

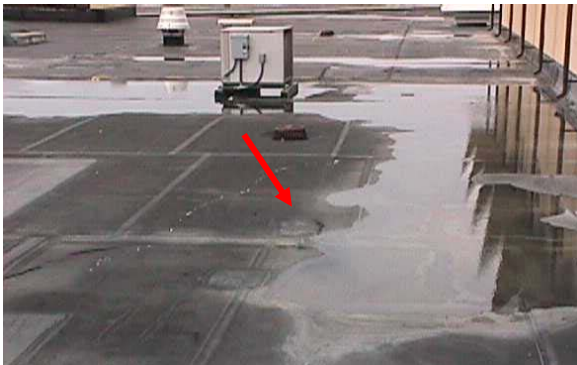
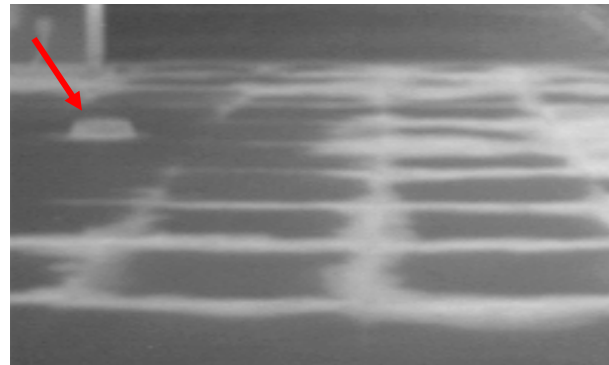
FIGURE 4

**SECTION OF EPDM ROOF WITH
STANDING WATER**

**INFRARED IMAGE OF WET INSULATION
EDGES**

However, it is important to note that there are currently three types of instruments that are capable of detecting roofing system moisture. Infrared cameras (see **FIGURE 4**, Note: water seen in match photograph was not present at time of infrared inspection.) provide the only method that is real time visual with no data grid required. Nuclear gauges detect and measures hydrogen through the use of a radiation source. To accomplish the inspection of an entire roof, a grid would be established and data taken with the gauge at each point on the grid (see **FIGURE 5**). The third type of nondestructive testing instrument is the electrical capacitance gauge. This gauge measures the dielectric constant of the test point. Roof materials have a value of 2-4 and water approximately 80. Once again a data grid is required and the instrument is either placed or rolled on the roof surface and the gauge meter read the dielectric constant for locations of wet and dries roofing materials.

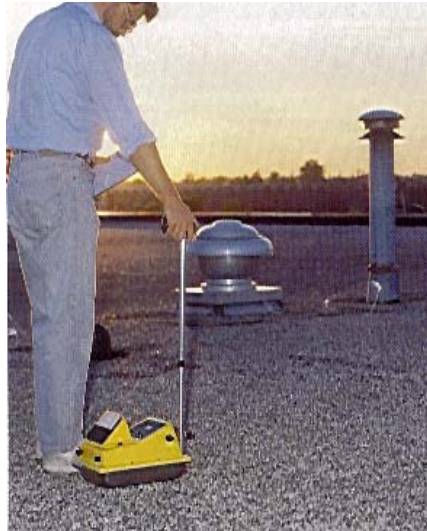
FIGURE 5
Plotting data points on a low slope roof surface with a neutron thermalization moisture meter.

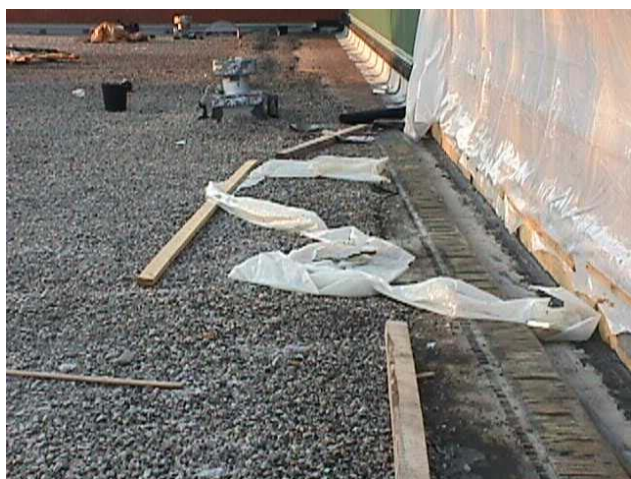
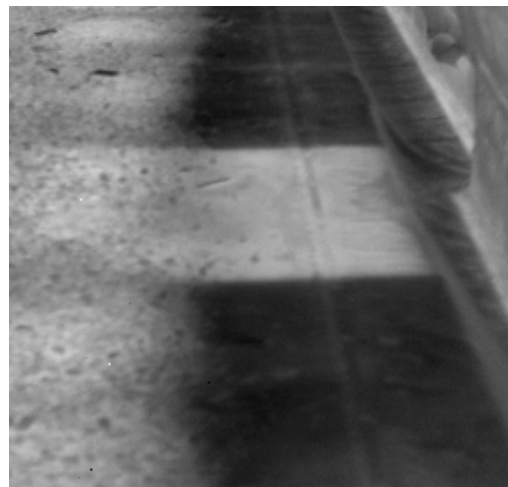
FIGURE 6

NEW CONSTRUCTION CONNECTED TO EXISTING INFRARED SHOWING WET INSULATION
