# “NDE of Reinforced Concrete Strengthened with Fiber-Reinforced Polymer Composites using Infrared Thermography”

*Jeff R. Brown and H.R. Hamilton III*

*University of Florida – Department of Civil and Coastal Engineering*

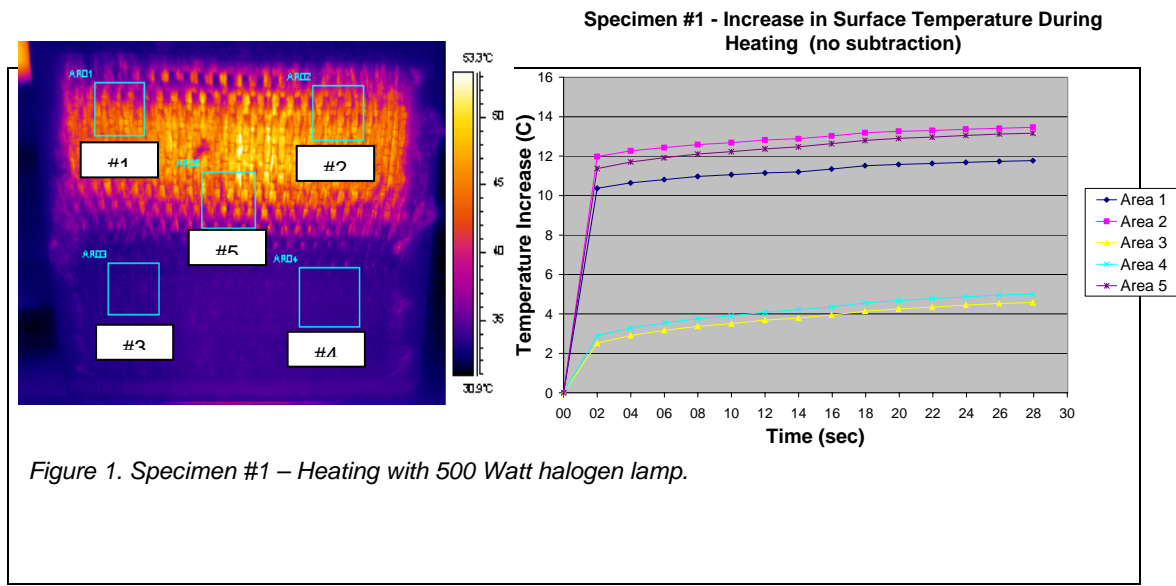
One major problem encountered was the presence of reflected heat energy from the heat source. Figure 1 shows a thermogram for specimen #1 (control) after only two seconds of exposure to the 500-Watt halogen light. The temperature of the specimen prior to removal of the shield was around 32 C, however, the thermal image recorded after two seconds of heating indicates temperatures on the surface of the specimen in excess of 50 C. This is due to infrared radiation generated by the high temperature halogen bulb and then reflected by the specimen.

This problem can be eliminated using an image subtraction feature provided by the Researcher software. As long as neither the thermal imaging camera nor the heat source moves, the amount of reflected IR radiation picked up by the camera remains constant for each pixel in the thermogram sequence. By subtracting the first thermogram image in a sequence from the subsequent images during heating, the reflected radiation is effectively removed. Figure 2 shows results from the same heating sequence with the reflected radiation removed. There are no longer any drastic jumps and all five of the selected areas exhibit the same general heating trend.

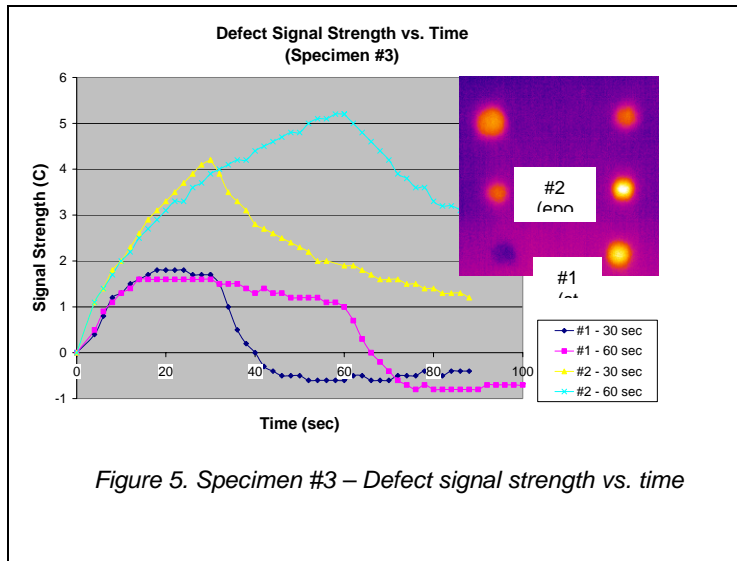
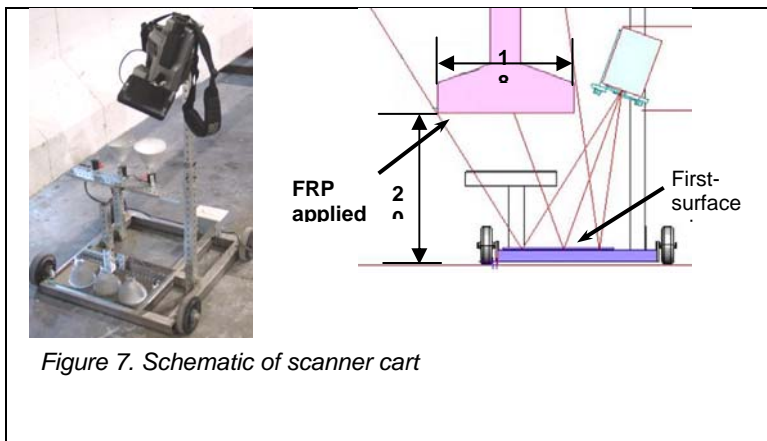
Specimen configuration and IR inspection results for specimen #3 are presented in Figures 4 and 5, respectively. All six of the implanted defects in specimen #3 were apparent after 30 seconds of heating with the 500W halogen light. Different defect signal strengths were also obtained due to the different thermal characteristics of the defect material. The most interesting observation relates to the steel defect. Since the steel has a higher thermal conductivity than the surrounding concrete, the surface above the defect becomes cooler than the surrounding areas.

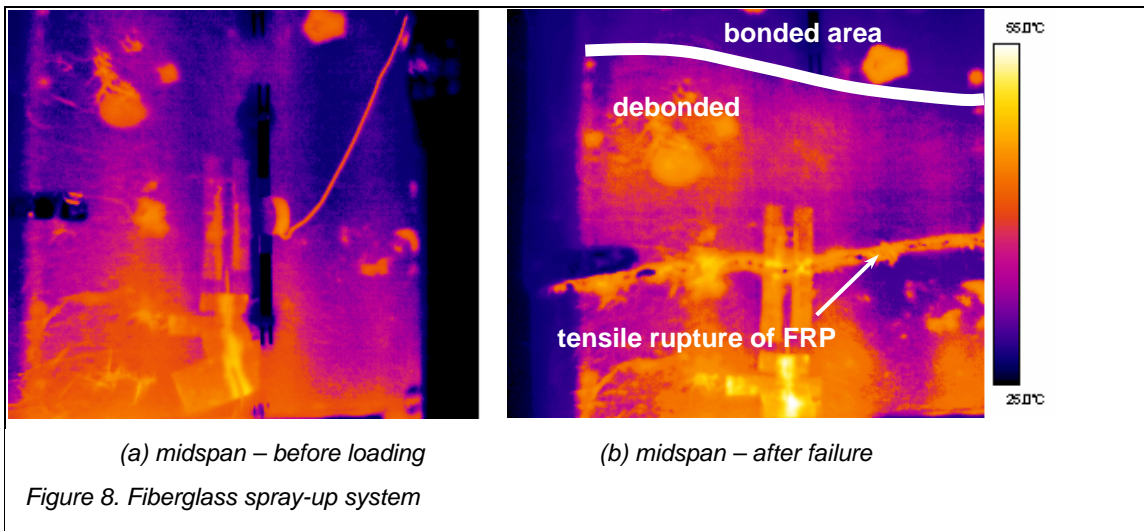
The FRP strengthening system shown in Figure 8 was constructed using a unique spray-up method in which chopped glass fibers are blown onto the concrete surface along with a vinylester matrix. The thickness of the FRP on the bottom surface varied between 0.3 in. and 0.4 in. Figure 8(a) shows an infrared thermogram of the system at midspan prior to loading. The visible defects in the thermal image are a result of small amounts of fibers falling down before the system fully cured. Some of the defects were formed very near the surface and were easily detectable with the eye. Some of the fainter defects, however, were not readily discernible. Figure 8(b) shows the same area at midspan after the girder failed. The failure mode for this specimen was tensile rupture of the FRP. During rupture, a portion of the FRP expanding outward from the rupture point between 6-8 inches in both directions debonded from the concrete surface. This area was easily detectable via acoustic sounding. The thermal image recorded of this area, however, only reveals a minor variation in surface temperature. The thickness of the FRP system combined with the low thermal conductivity of the glass fibers makes debonded areas difficult to detect. A possible solution would be to introduce more heat to the surface.

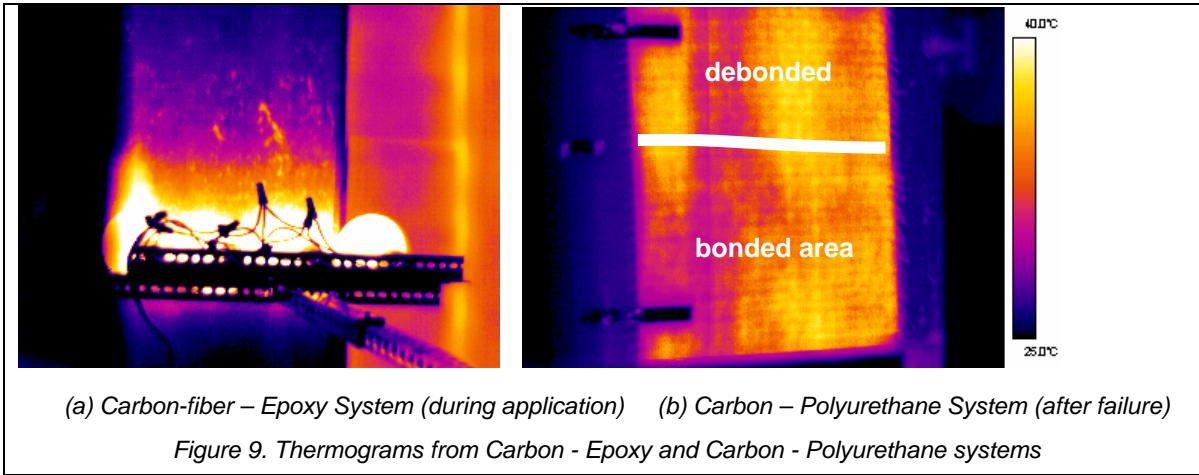
Figure 9(a) shows the first layer of a three-layer carbon-fiber system (applied via the wet-layup method described above). The small defects present are similar to those encountered in the 12"x12" control specimens. Unfortunately, after the additional layers of fabric were applied to the surface it became difficult to detect the presence of the debonded areas.

The failure mode for girder #2 was debonding of the applied FRP system. After failure, only a short six-foot portion of the FRP remained bonded at one end. Figure 9(b) shows an IR thermal image taken at the interface between the well-bonded portion and the severely debonded portion after failure. From this image, it is impossible to discern the debonded area. The polyurethane matrix that was used effectively insulated the carbon-fibers from the concrete. Regardless of the amount of heat applied, the temperature on the surface above a debonded area remained the same as above a well-bonded area.
