Detection of air blisters and crack propagation in FRP strengthened concrete elements using infrared thermography

C W Hu*, J K C Shih+, R Delpak*, D B Tann*

* University of Glamorgan, Pontypridd, Mid Glamorgan, CF 37 1DL, UK

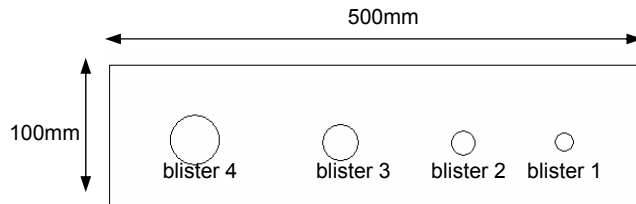
Figure 1. Illustration of embedded blister locations

Front Elevation

Note: Sizes of the bubbles, d: diameter

blister 1: $d = 16\text{mm}$, blister 2: $d = 18\text{mm}$, blister 3: $d = 20\text{mm}$. and blister 4: $d = 30\text{mm}$

The blisters were modelled using rings of 1mm deep, cut from plastic piping, and embedded between the interface of Carbon Fibre Reinforced Polymer (CFRP) and concrete specimen. The commercially available pipes had diameters of 16, 18, 20 and 30 mm respectively with negligible variation in respective diameters, see **Fig. 1**.

circular shapes or patterns with higher temperature are expected to be observed, see Fig. 1. However, the distorted hot areas have appeared and registered by images displayed in Plates 2 (a) to (d). This is due to the bad workmanship which resulted in the undesired thin gap around the blisters between CFRP and the concrete. This was confirmed after the removal of CFRP plates from the beams as seen in **Plate 3**.

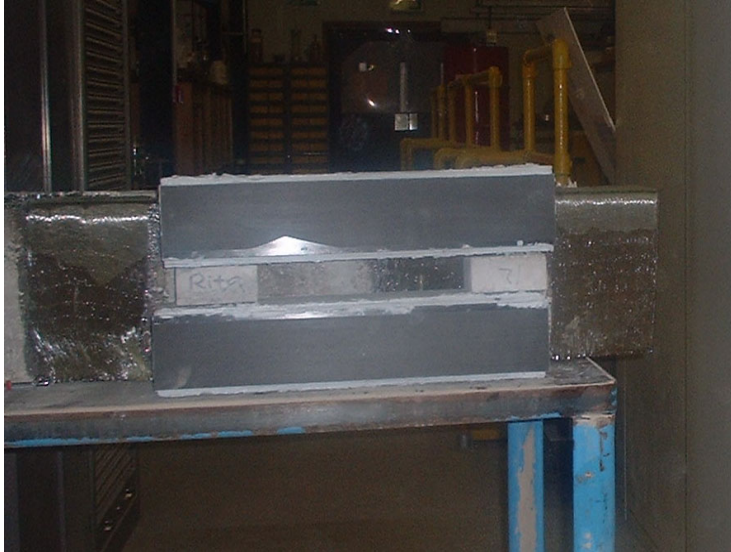
Plate 1. CFRP plate concrete specimens, where the artificial blisters are embedded between the interface of composite and substrate

After concrete surface preparation, the cut “blisters” were lightly pressed to the substrate before bonding the laminate and squeezing out unwanted natural air-bubbles with a “wall-paper” type roller. All bonded surfaces were allowed to be cured for at least one week before testing. **Plate 1** shows the actual visual image of composite specimens with the embedded artificial voids.

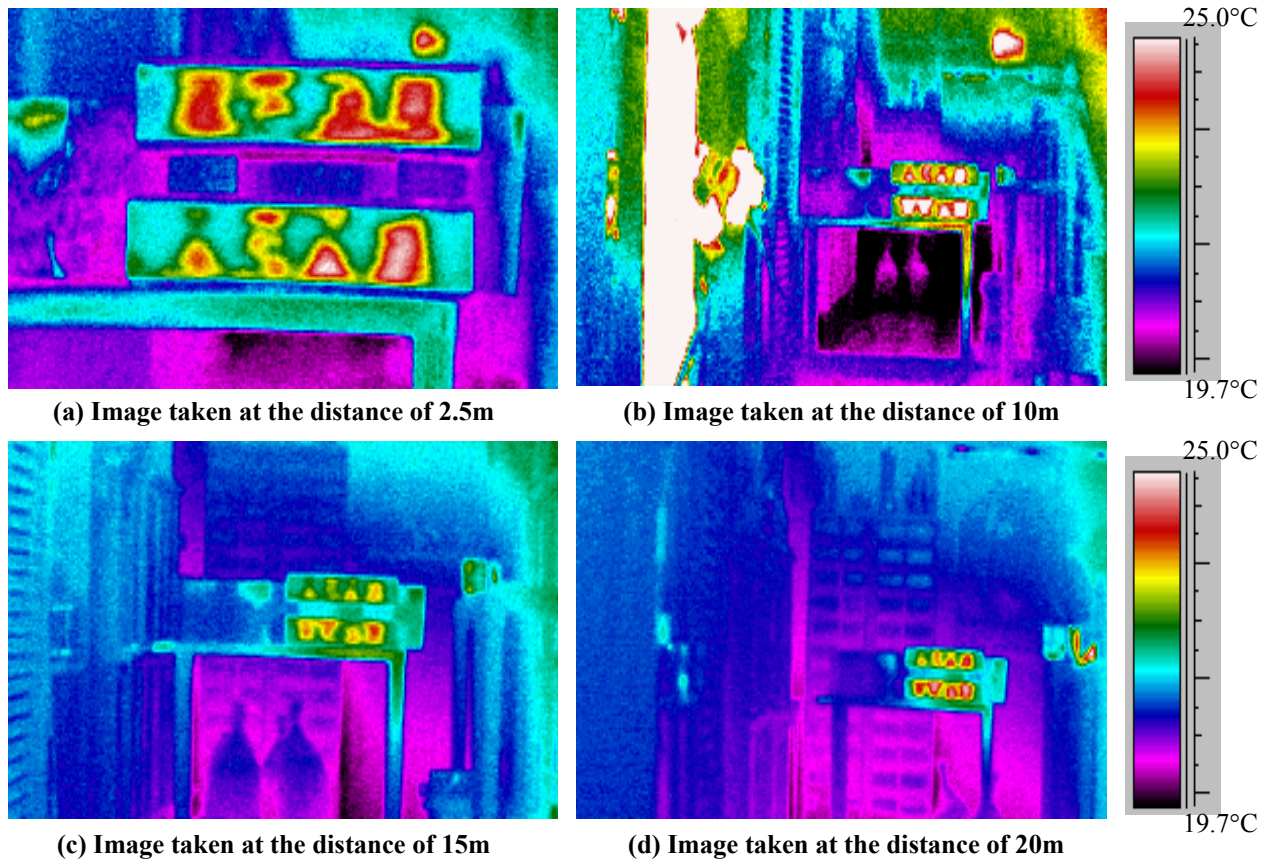
Plate 2. Thermal images taken at various distances for the concrete samples plated by CFRP (see Plate 1 for the corresponding actual photograph)

Plates 2 (a)-(d) show the thermal image of the concrete beams, strengthened by CFRP materials, taken at different distances.

From the thermal image in Plates 2 (a) to (d), it is clearly possible to locate the positions of the artificial blisters where the areas with higher temperature existed. Even though the distance between the surface of samples and the transmission line of IR lens is increased up to 20m, the locations of air-voids covered by CFRP were still identified using the IR camera. If the bond line between CFRP and concrete (excluding blister locations) has no air voids, four

The specimens with the areas devoid of adhesive (highlighted by a marker pen), where the external heat flow supplied from the surface is supposed to be trapped, are clearly identified. By comparing the actual photograph shown in **Plate 3** with the thermal images represented in **Plates 2 (a) to (d)**, the potential of thermographic technique in detecting the defect locations in FRP strengthen specimens/ structures is justified.

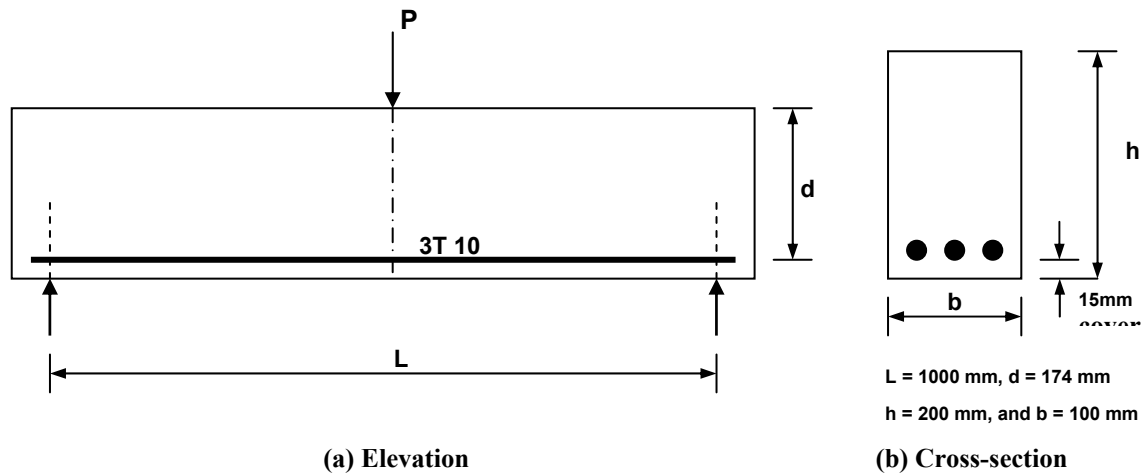
Figure 2. Configurations of test beams

A $100 \times 200 \times 1200$ mm concrete beam was reinforced in tension with three T10mm bars and laminated partially by Fibre Glass composite (GFRP) material. The GFRP sheets were applied through wet lamination using a two-part epoxy based adhesive. In addition, the reinforced concrete (RC) beam was placed on the jack and subjected to a 3 point loading condition, as shown in Fig. 2.

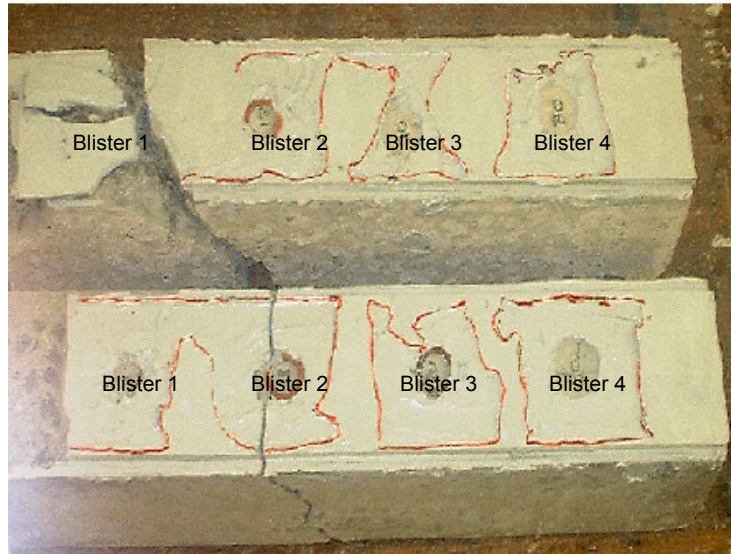
Plate 3.

Actual photograph of concrete samples, after laminated CFRP were artificially removed

(see Plate 1 for its corresponding photograph)

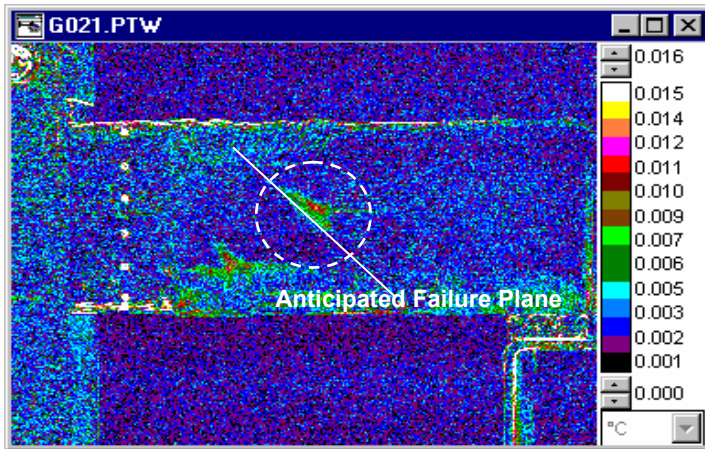
Plate 4.

Thermal image taken during 45 to 55 kN cyclic load range

The continuous cyclic load action is expected to accelerate the formation of cracks, and hence initiate the generations of the heat through the friction at the areas, where the “discontinuities” are likely to be formed. Thermal images taken during the cyclic loading level of 45-55 kN is shown in **Plate 4**, where the area with triangular shape, highlighted by a white circle, indicates the dissipated energy due to the friction of the crack tips. From the image, it is predicable that the failure would take place within the region with the higher temperature and the possible failure plane would be about 45° along the triangular plane.

Plate 5 shows the thermal image of the test sample taken (fortuitously and) immediately, after the failure had occurred. It is observed that the actual failure plane shown in **Plate 6** is almost identical to the predicted one anticipated in **Plate 4**.

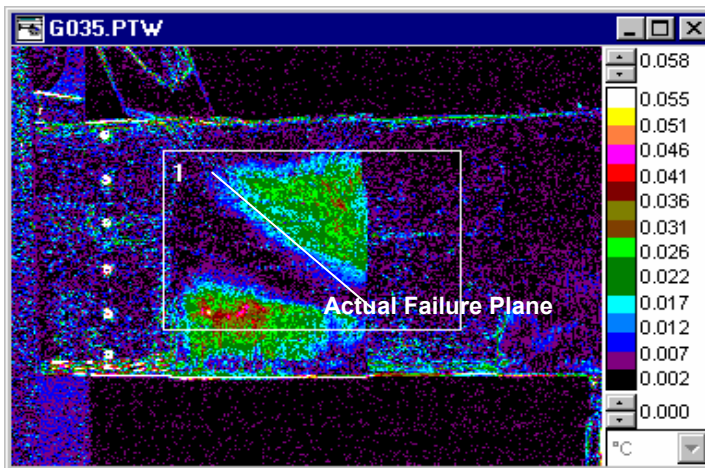
Plate 5.

Thermal image taken after failure occurred (at the cyclic load range of 67.5 - 82.5kN)

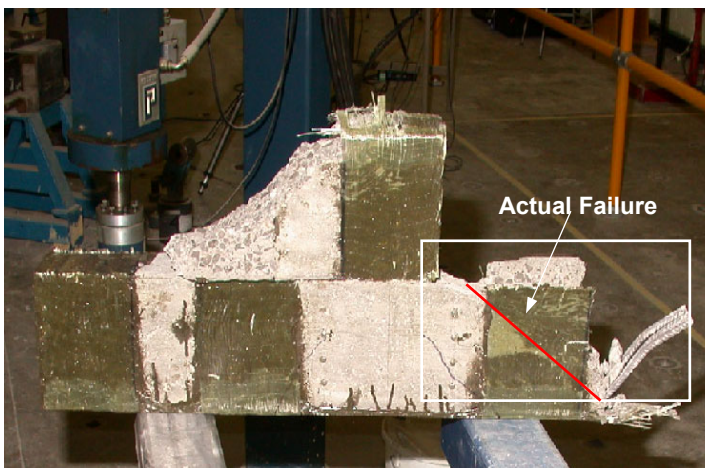
Plate 6.

Actual photograph for 1.2m concrete beam laminated by GFPR taken after failure occurred
