Finding Termites With Thermal Imaging Cameras

Ken James and David Rice

Termicam Pty Ltd, Melbourne, Australia

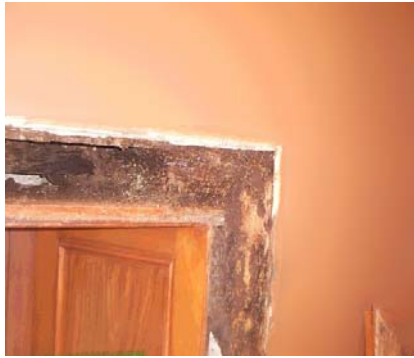
Fig 1a. Visible image of door jam, no evidence of termite infestation

The images in **Figure 1** below are an example of how thermal images from an infrared camera can detect heat patterns and can be compared to visible images to identify the location of a termite infestation. The images were taken in a house in Australia, in May 2002 during an inspection and show the top section of a doorway. The normal visible image taken with a conventional camera does not indicate any termite activity but a thermal imaging camera reveals a hot spot that shows as yellow in the top right hand corner of the door jam. This is where the termites were very active and had eaten away most of the wood material. This technology allowed an early detection of the termite problem, and eradication could proceed before the damage was too great, thus saving the owner thousands of dollars in repairs at some future date.

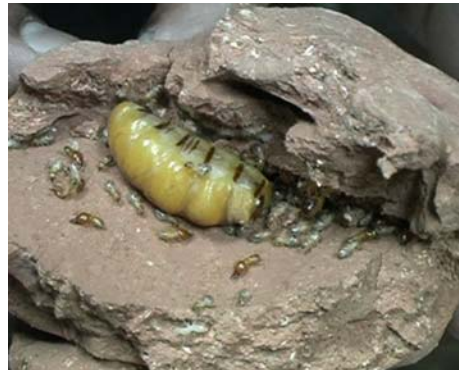
Fig 2b. Termite Queen can lay thousands of eggs per day. Note Queen, soldiers (with large heads) and small worker termites (which eat the wood).

Termites get their food by eating wood, which is made up mainly of cellulose. A special bug called protozoa, lives in the stomach of termites and these protozoa helps to break down the cellulose. The digestion of cellulose generates heat and when large numbers of termites in nests get together, there is a lot of heat concentrated in one place. This heat moves through the walls or floor of a house and it is this thermal pattern that can be detected with a thermal imaging camera.

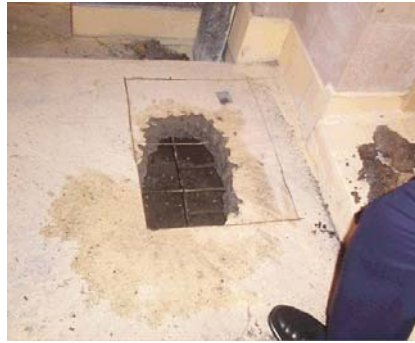
Fig 4. Hole in concrete floor, to destroy termites found with thermal imaging.

One example of this is parliament house in Brisbane, Australia. TermiCam started thermal imaging at Brisbane parliament house in 1999. After finding a heat pattern out on the balcony in March 2001, a large nest in the floor of the balcony was indicated. This was around about the second floor in what they call the reading room. The balcony was pulled up in September 2001 (**Figure 4**) by cutting a hole in the concrete slab and a termite nest was revealed.
